Institute of Refrigeration

Valve Failure Safety Alert

Valve failure results in ammonia refrigerant burn injury

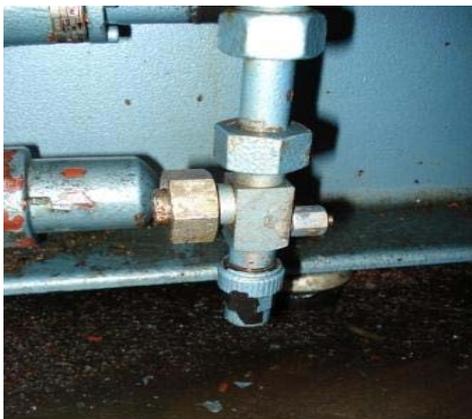
The valve construction included steel pipe stubs brazed into the valve body, screwed connections with nuts on the other end of the pipe stubs allow the valves to be connected to the systems or have blanking caps fitted. The valve that failed was connected to the system using a nut on the stub 90° to the valve stem; this stub came apart from the valve body. The second stub in line with the valve spindle had a blanking nut fitted as it was the refrigerant charging connection.

Valves with these types of brazed in connections are available in a range of sizes and are widely used on refrigeration systems. The photograph

shows a typical valve (not the actual which failed); in this application the blank is on the stub at 90° to the valve stem and plant connection is in line with the valve spindle.

- The failure was due to corrosion under the preformed brazing filler metal thus weakening the joint on to the valve parent metal.
- The corrosion had started externally.
- The valves were fitted on a section of plant cycling from sub zero to above zero temperatures.
- Forces used prior to the incident to fit the valves, remove caps or to fit charging lines etc may have damaged the valve.
- The paint finish on the valves had deteriorated.
- Ammonia was not considered to be a factor in the failure and it is believed that a serious incident would have occurred regardless of the type of refrigerant in the system.

- Before commencing work on any Refrigerating system wear PPE as required by your employers' Risk and COSHH assessments for the refrigerant within the system PLUS in the case of Ammonia have a respirator available and to hand.

- When working on any type of valve with screwed connections always use a check spanner to hold the body of the valve whilst undoing connections, caps, plugs, etc, with another spanner.

- Identify all refrigeration plants containing these types of valves installed in parts of the system susceptible to corrosion e.g. regular cycling from sub zero to above zero temperatures or frequent operation in a wet condition. Then DO NOT ATTEMPT to use the valves until an appropriate risk assessment is carried out for either the replacement or the continued operation of the valves.

- When working on refrigeration plants fitted with these types of valves installed and operating in dry conditions such as in HP discharge or liquid pipe lines etc, DO NOT ATTEMPT to work on the valves without firstly isolating upstream and downstream of the valve in order to limit potential gas loss.

- Clean and apply refrigeration oil to threads before replacing screwed connections.
- Regularly (quarterly) examine valves for leakage and corrosion and repair, paint or replace as required.

- Consider if insulation is required to prevent ice from building up around the valve and exerting forces on the pipe stubs.
